June 18, 2013

To: Our valued customers using Flow Meter FM-03-B

Model FM-03-B with Defective Flow Rate Adjustment Valve

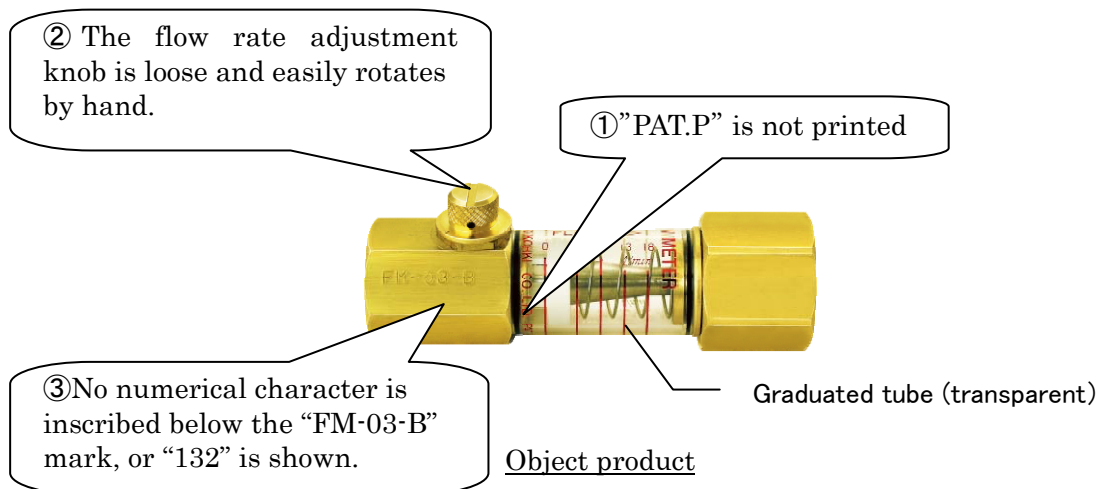
We have found that when Flow Meter model FM-03-B, produced from October 2011 to February 2013, is used with the flow rate adjustment valve in a halfway open position, the valve will turn in the direction to close the fluid passage by itself, due to the incomplete tightening of the internal component of the valve, and the amount of flow will be decreased. If, however, used with the valve in a fully opened position, it will not cause such a phenomenon, and the amount of flow will not be decreased.

- Model : Flow Meter FM-03-B (Flow meter with special valve for mold cooling line)
- Production period : October, 2011 - February, 2013
- Characteristics of the object products
 - ① "PAT.P" is not printed on the polycarbonate graduated tube.
 - ② The flow rate adjustment knob is loose and easily rotates by hand.
 - ③ No numerical character is inscribed below the "FM-03-B" mark, or "132" is shown.

On and after June 18, 2013, we are ready to send a replacement product at the request of the user of above model FM-03-B. For the replacement, please contact the following:
